Mobile Intel[®] Pentium[®] II Processor Specification Update

Release Date: May 2001

Order Number: 243887-031

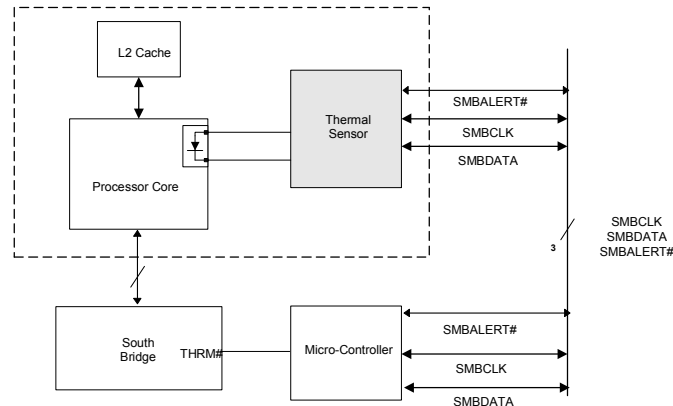
Figure 1. An Example of Microcontroller Driven Thermal Management

B30. Thermal Sensor May Assert SMBALERT# Incorrectly

Problem: The Mobile Pentium II processor and the Pentium II Processor Mobile Module have a thermal sensor that monitors the processor core's temperature. Please note that desktop systems could have a similar thermal device. The thermal sensor asserts SMBALERT# if the processor temperature exceeds the temperature limits set in the Alarm Threshold Registers (T_{HIGH} , T_{LOW}). It also sets the corresponding Status Register bits to identify the cause of the interrupt. Figure 1 gives one example of the how the SMBALERT# signal could be used in a system.

Under the conditions described below, the thermal sensor incorrectly generates the SMBALERT# interrupt. All of the following conditions must be met to trigger a false interrupt:

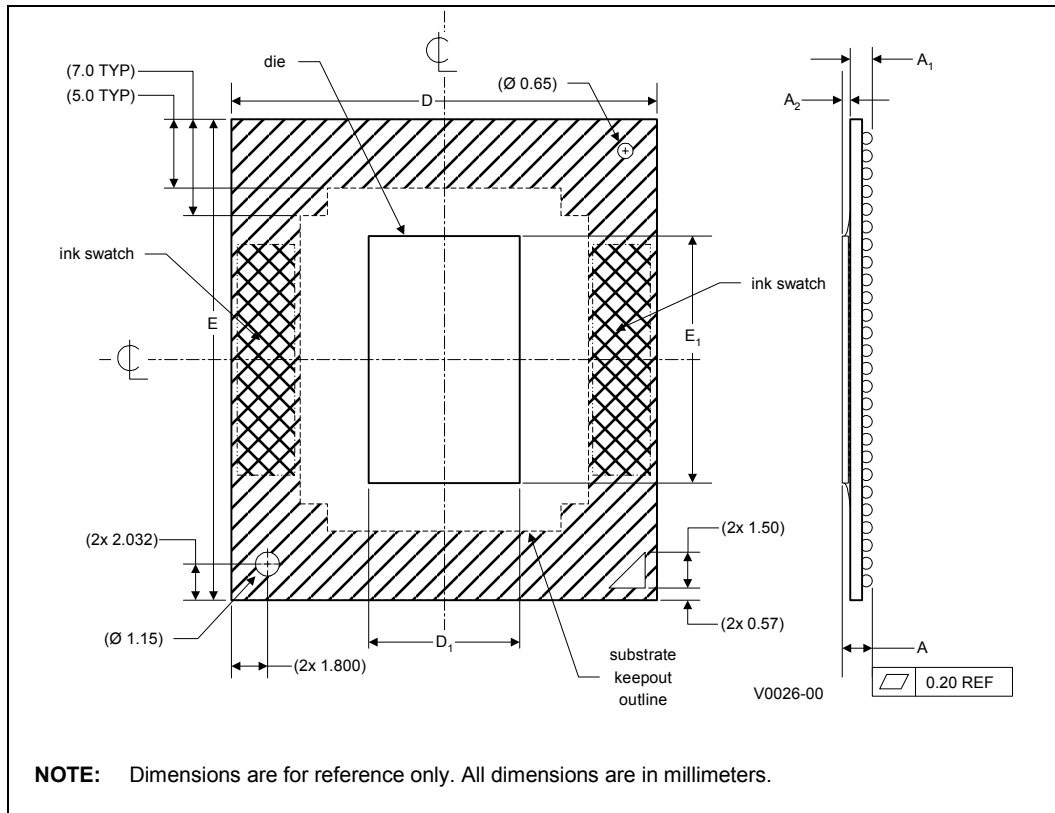
Figure 5.3. Surface-Mount BGA1 Package—Top and Side View

The following table and figures show the updated mechanical specifications for the BGA1 package, listed as Table 5.2, Figure 5.3 and Figure 5.4, respectively, in the *Mobile Pentium® II Processor in BGA Package at 366 MHz, 333 MHz, 300PE MHz, and 266PE MHz* datasheet.

1. The number shown here is different from that in the 243887-010 revision of this specification update. The maximum reference number is used.

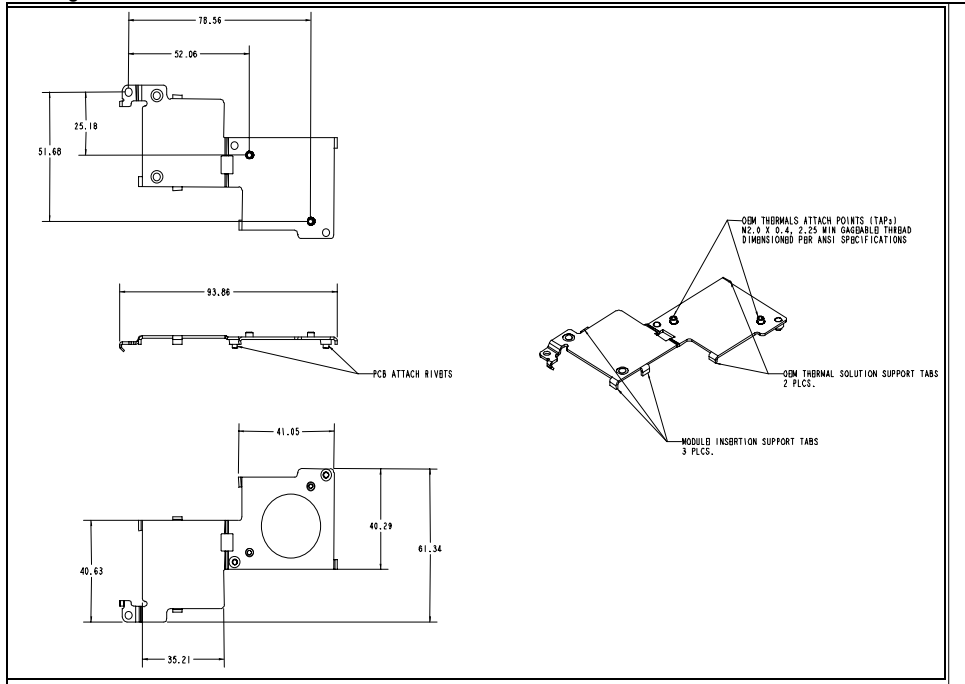
Figure 1. TAP Gageable Thread Clarification

OEM Thermal Attach Points (TAPs) M2.0 x 0.4, 2.25 min gageable thread dimensioned per ANSI specification.

See Figure 1 below for more information.
